PRELIMINARY LIMITED STRUCTURAL EVALUATION OF
RAND ENGINEERING & ARCITECTURE DPC

Re: 286 Rider Avenue
Limited Structural Evaluation

**286 RIDER AVENUE
PHOTOGRAPHIC SUPPLEMENT TO
RAND MARCH 25, 2022 LIMITED STRUCTURAL EVALUATION**

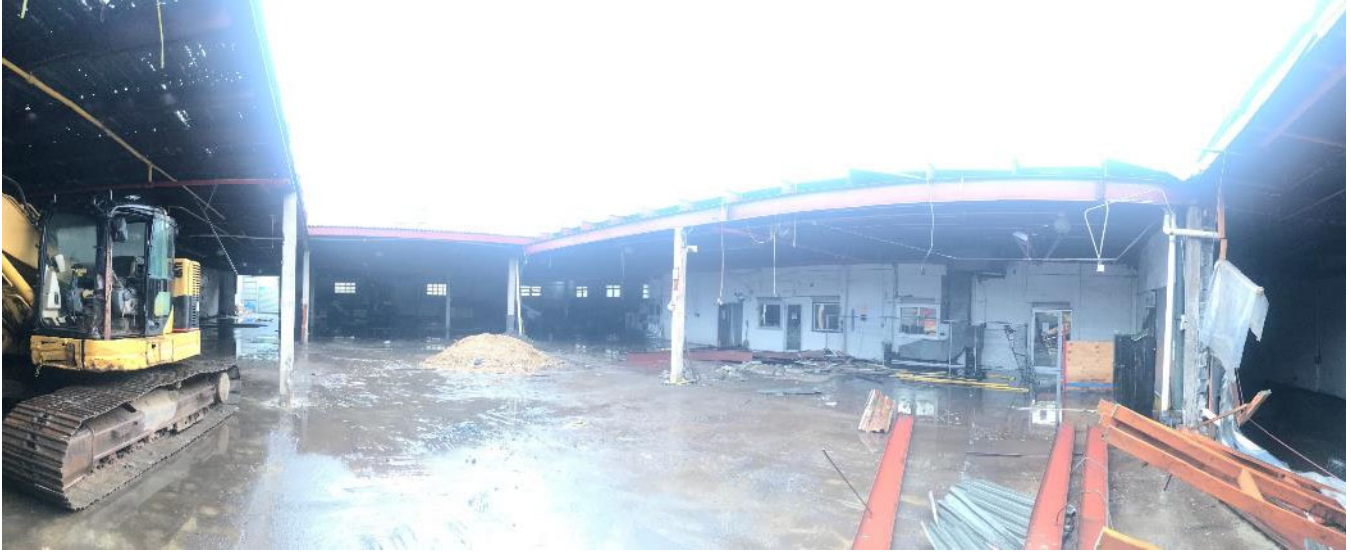
- The roofing system has been completely removed, exposing the interior spaces and structure to the elements. Standing water is present throughout. The finished office spaces in the northwest corner are completely waterlogged, with ceiling finishes and insulation falling to the floor (photos 1 through 4).

- Two column bays of the roof structure have been completely removed, including metal deck and steel beams. It appears that the steel has been torch cut over the remaining girders that now frame the perimeter of a new opening (photos 1 and 5).

Photo 1. The warehouse interior is open and exposed to the elements.

- The entire structure is currently exposed to the elements due to the lack of roofing system and large and small openings through the metal deck. Temporary protection to divert rain water should be installed to protect the structure and foundations from ongoing deterioration and eventual destabilization. Roof protection should incorporate securing the remaining metal deck to avoid portions becoming dislodged.

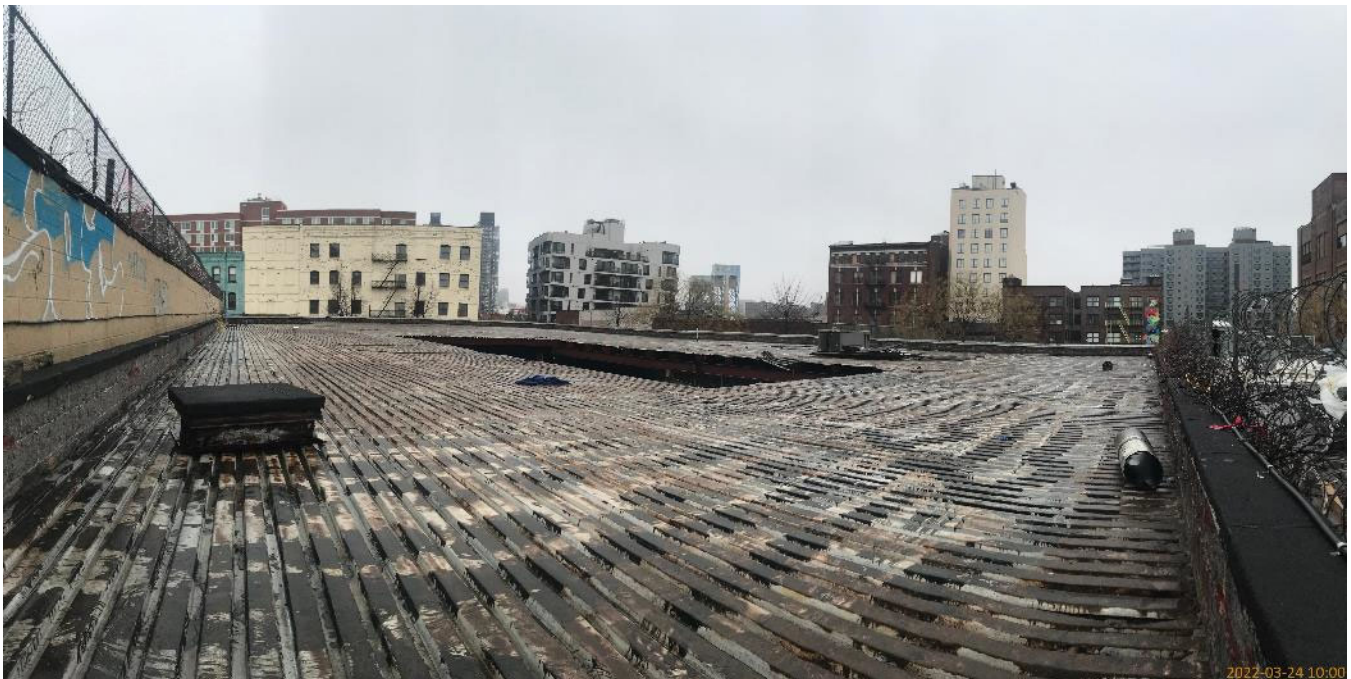
Photo 2. The roofing system has been completely removed down to deck.

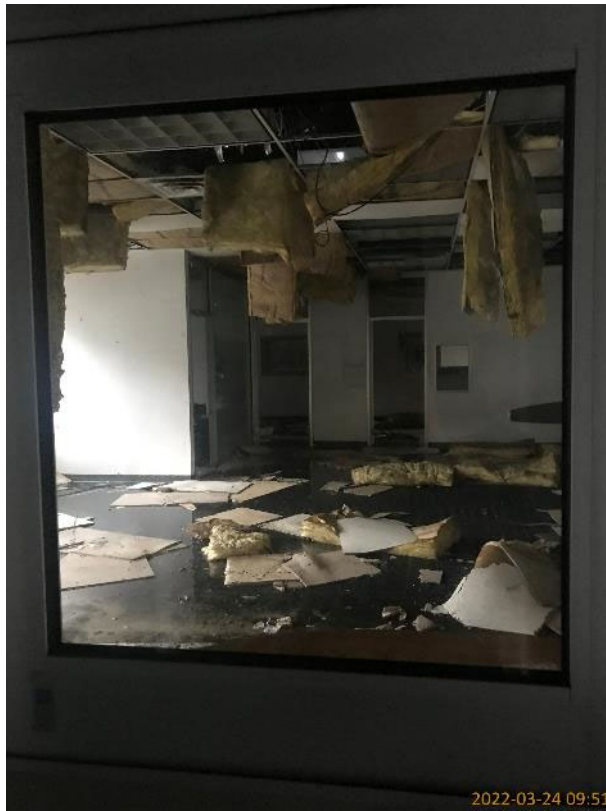
Photo 3. Finished office spaces are waterlogged with finishes and insulation falling to the floor.

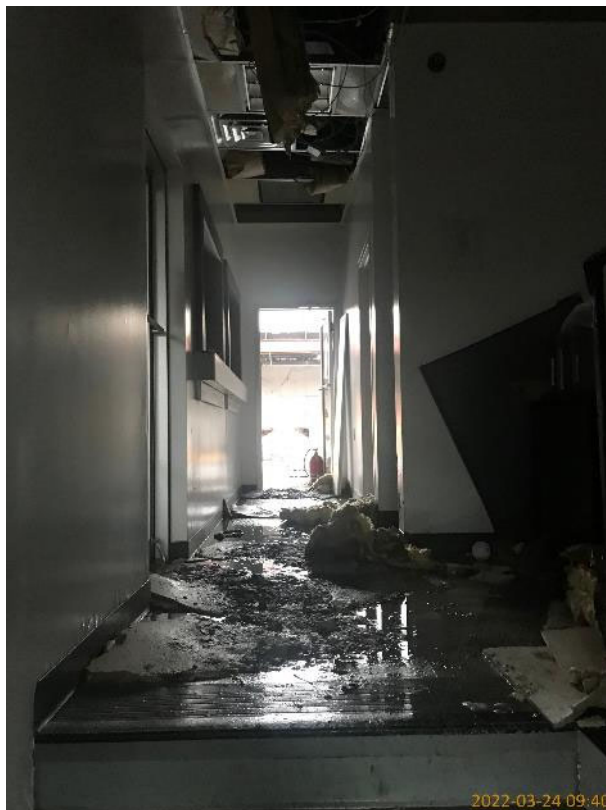
Photo 4. Finished office spaces are waterlogged with finishes and insulation falling to the floor.

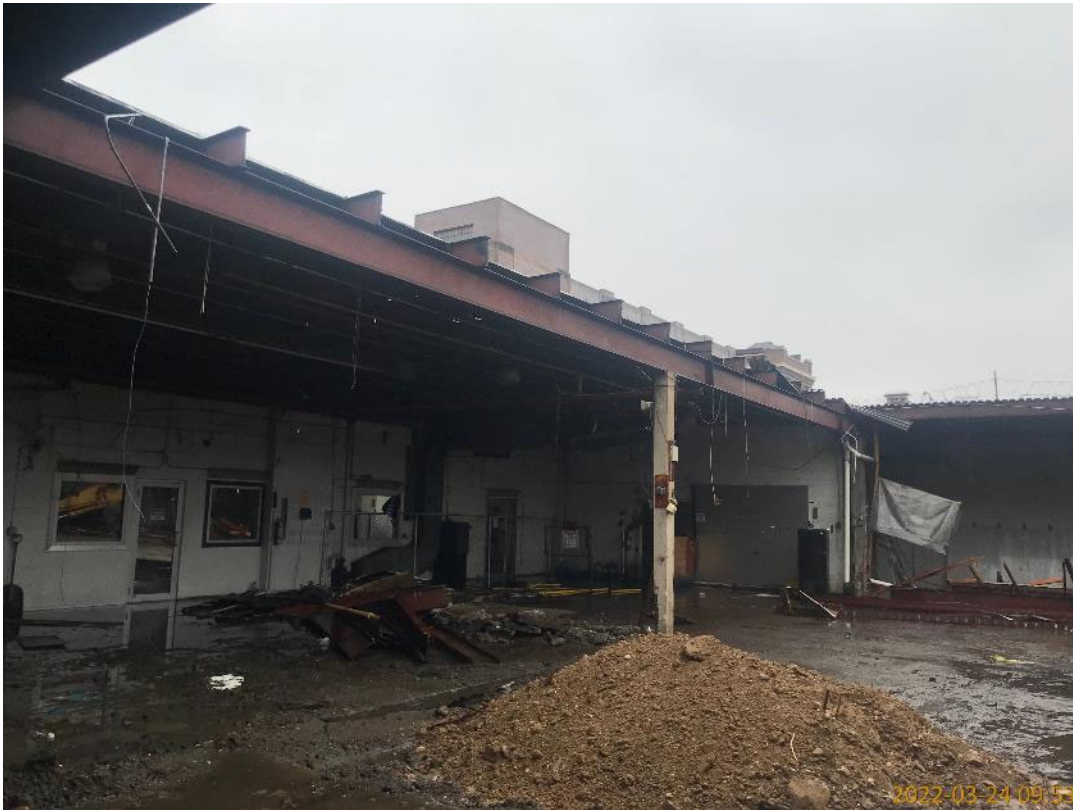
Photo 5. Two column bays of the roof structure have been removed.

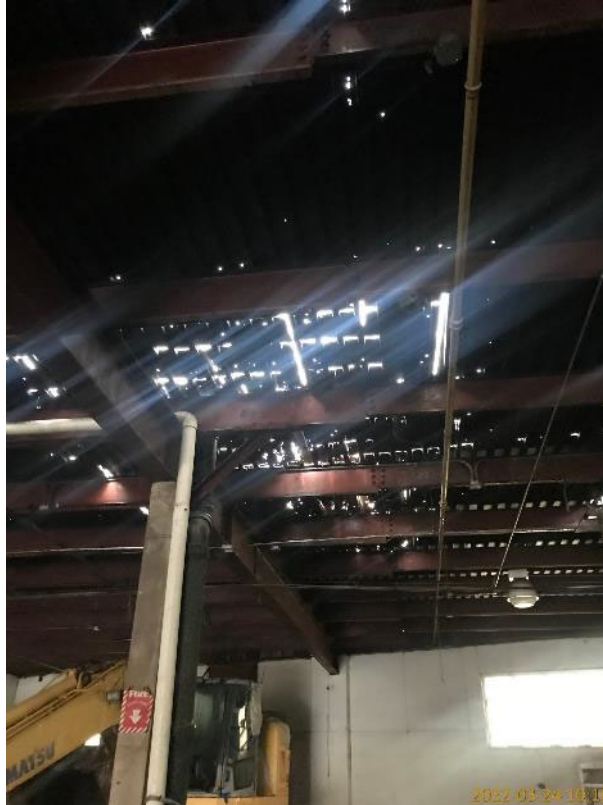
- The roof metal deck is significantly deteriorated, with holes and daylight visible throughout (photo 6). A walkthrough of the deck (including observation of attachment) from the rooftop was not performed due to safety concerns.

Photo 6. The roof metal deck is significantly deteriorated.

- The roof hatch at warehouse northeast corner should be closed off to prevent access to the roof which does not appear safe to walk on. It is possible that sections of the deck between framing are too weak to support snow loads and may fail in the future. Since the building will eventually be demolished, replacement or reinforcement is impractical. The roof should be re-evaluated by a structural engineer ahead of next winter for further recommendations. In general, the building should be secured and access restricted to only authorized personnel.

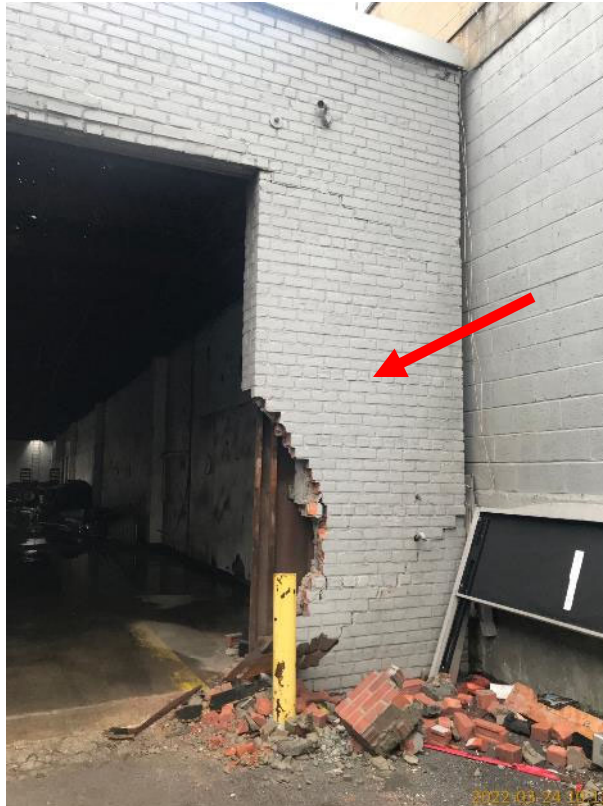
- The exterior wall section directly east of southeast gate opening (east jamb) appears to have been subjected to significant impact and is severely damaged. A large portion of masonry has fallen away and the remaining section is twisted and shifted out of plane, with cracking along the top and bottom (photos 7 and 8). **This condition is unsafe and requires stabilization and protection measures.**

Photo 7. Severe wall damage at the southeast corner.

- **The masonry wall section directly east of the southeast gate opening (east jamb) is unsafe and requires stabilization and protective measures. It is recommended that temporary shoring, bracing and protection be installed and/or that the wall section is carefully removed in a controlled fashion in order to prevent local collapse of the wall section in the future.**

The cost to execute protective measures recommended above ranges from \$15,000 to \$30,000 for the localized stabilization of the southeast corner and \$100,000 to \$200,000 to construct temporary roof protection with diverters. Please keep in mind that these budget projections are preliminary approximations only and need to be confirmed by the solicitation of competitive bids from qualified contractors. These preliminary projections exclude engineering, inspection and expediting fees, and other related costs.

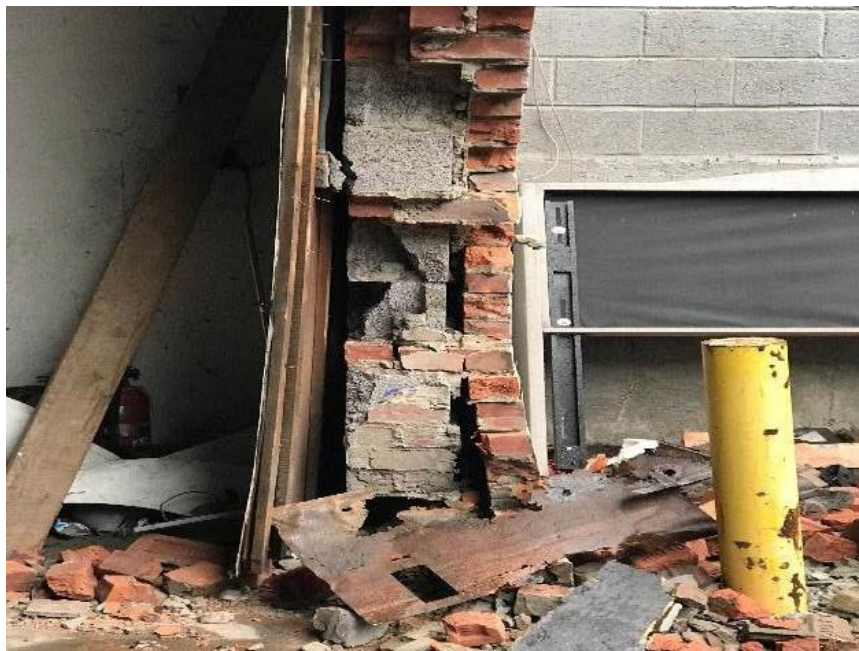
Photo 8. Wall structure at the southeast corner is compromised and requires stabilization and protection measures.

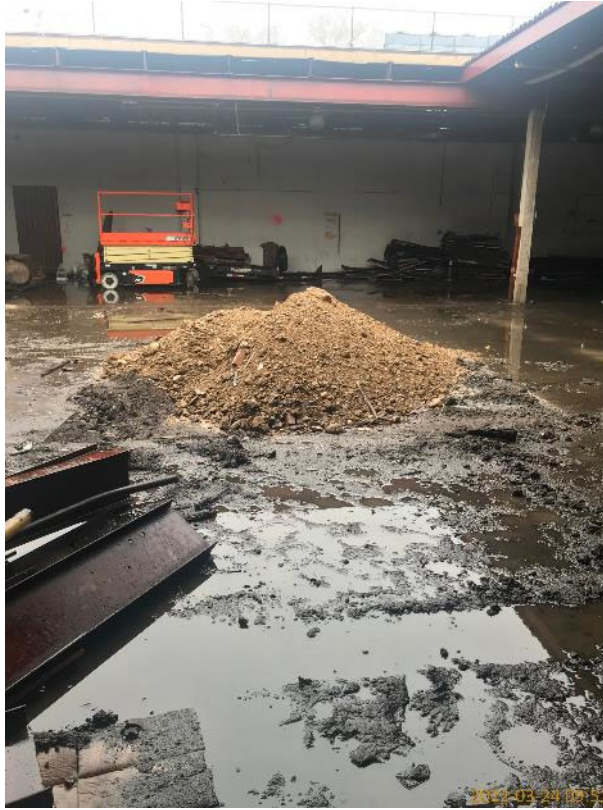
- A large opening has been cut into the concrete floor beneath the opening in the roof. It appears that underlying grade has been partially excavated and subsequently filled with an uncompacted pile of earth (photo 9).

Photo 9. A section of the warehouse floor slab-on-grade has been cut away, partially excavated, and filled with uncompact earth.

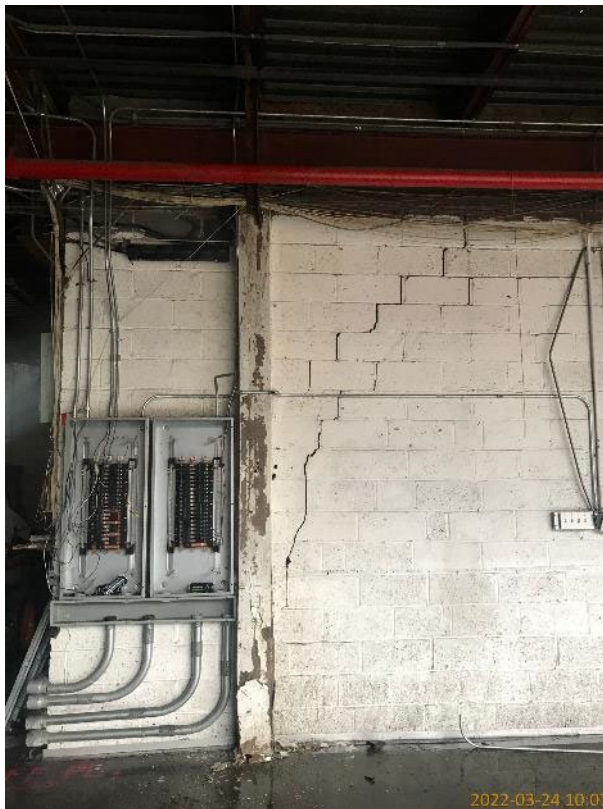
- A large crack was observed in the interior CMU partition. This condition is indicative of prior movement but does not appear to be a safety hazard at this time (photo 10).

Photo 10. Crack in CMU wall at southeast corner of the office enclosure.

- As a precaution, the large partition crack at the southeast corner of the office enclosure should be monitored for movement. It is recommended that a crack monitor be installed so that any widening or shifting can be easily observable.

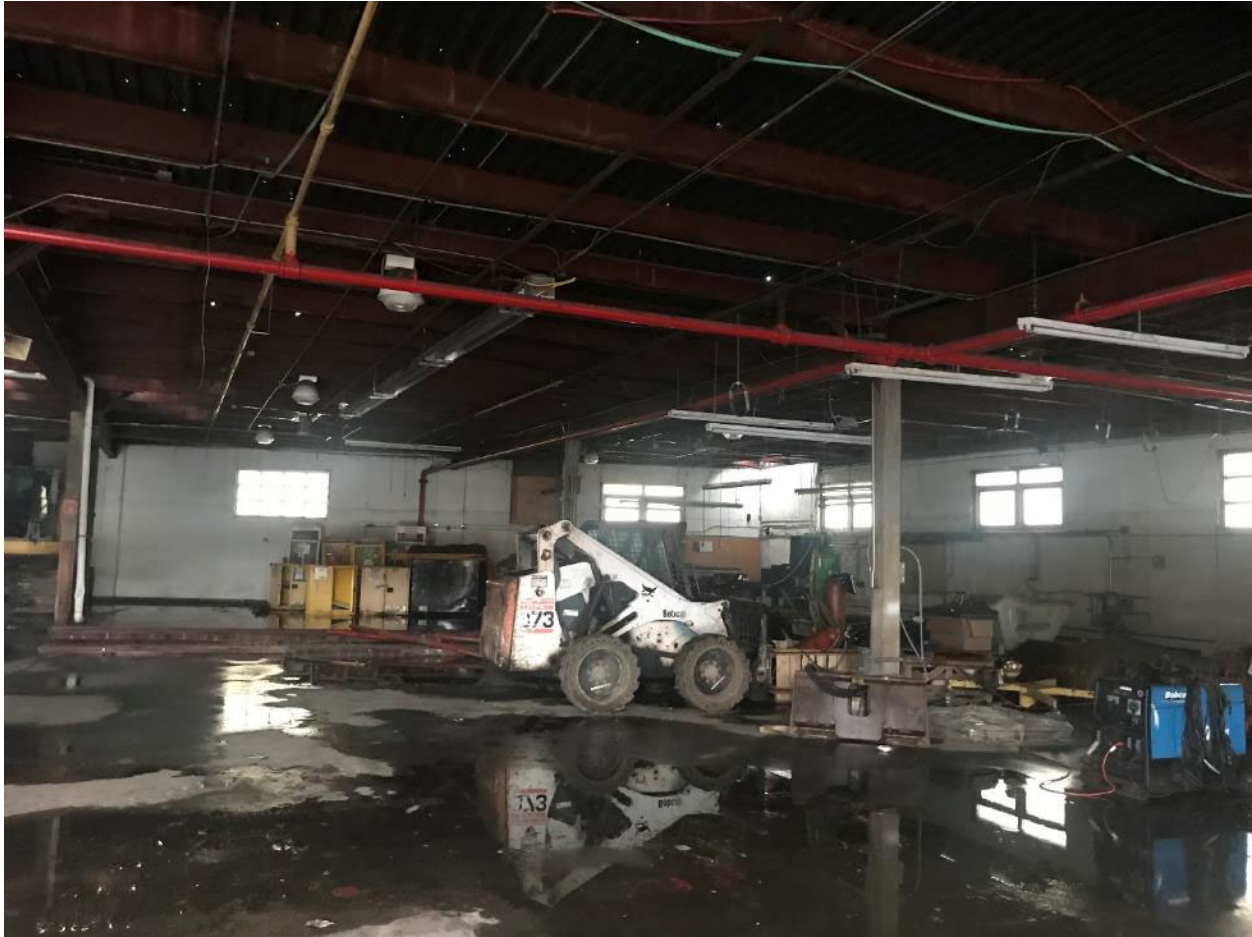
- Beyond the open/exposed roof and localized southeast corner wall condition, the building superstructure including perimeter masonry bearing walls, interior steel columns, and roof steel framing appear to be generally intact and stable (photos 11 and 12).

Photo 11. The building superstructure including perimeter walls, interior columns, and remaining steel framing appears generally intact.

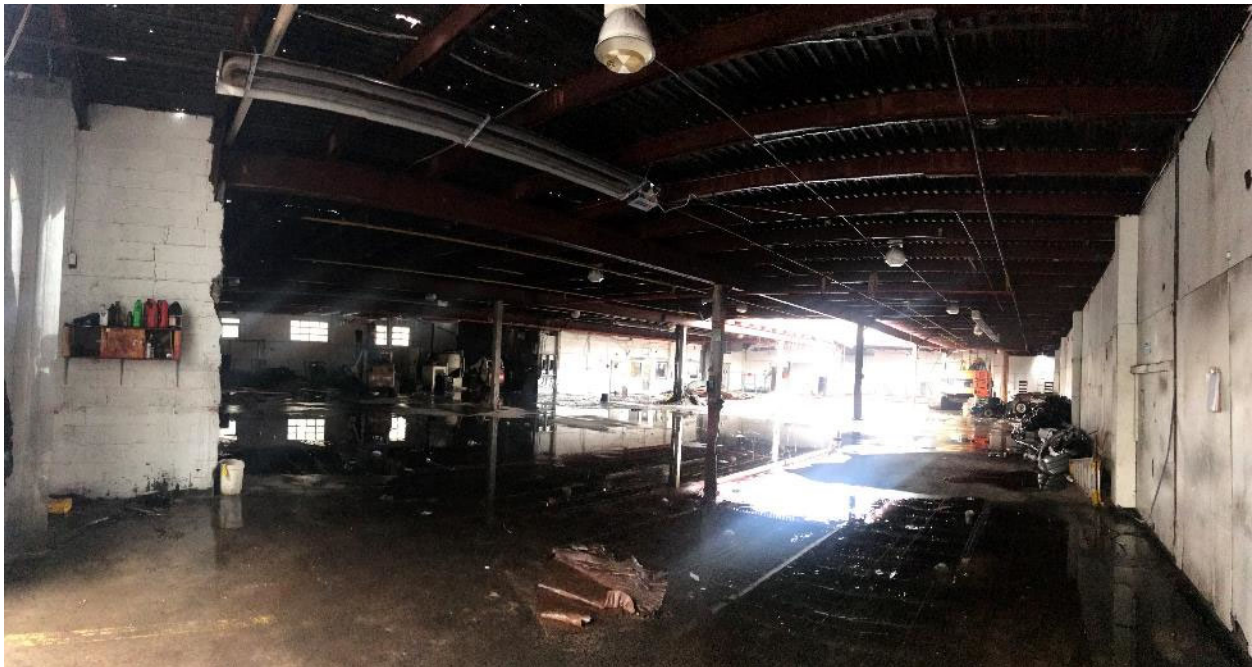
Photo 12. The building superstructure including perimeter walls, interior columns, and remaining steel framing appears generally intact..

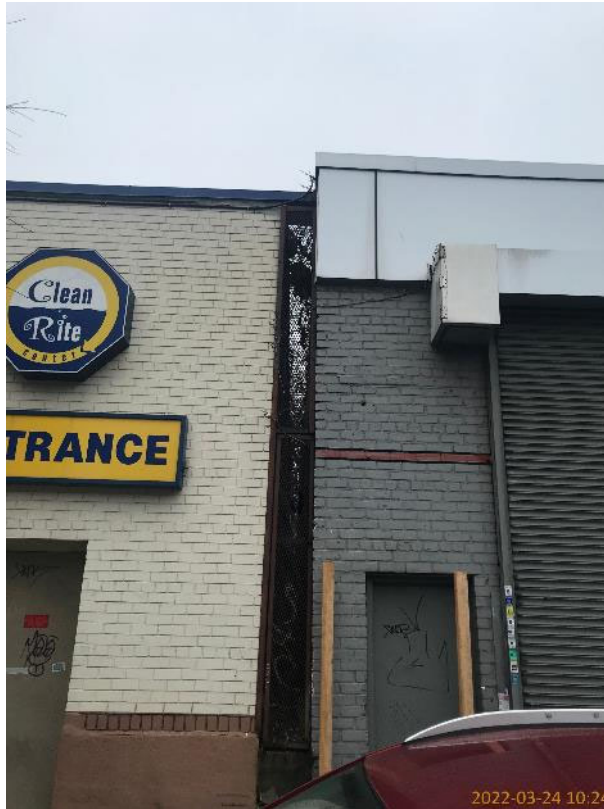
- The adjoining buildings to the north (supermarket) and east (laundromat) appear to be separated structurally at the property line. Barbed wire fences are situated at the roof perimeter preventing access to the site from the adjoining rooftops (photos 13 and 14).

Photo 13. Structural separation along the north property line.

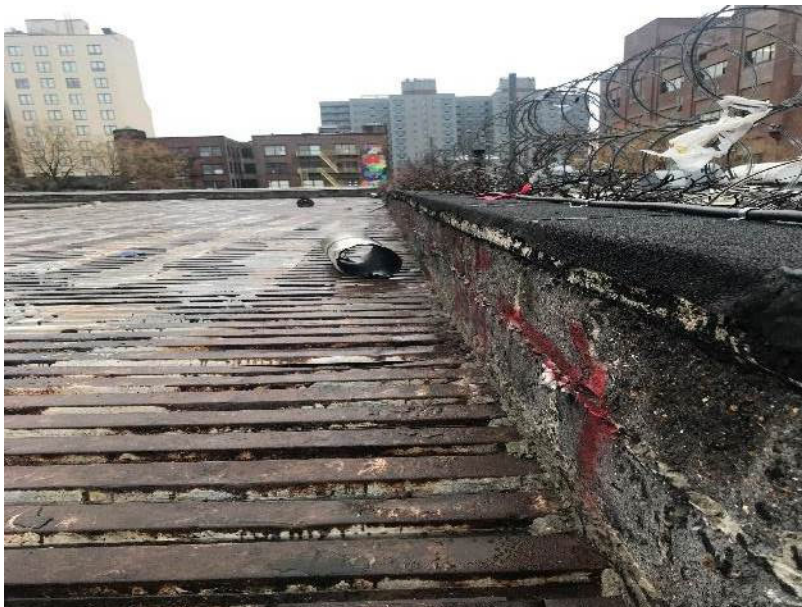
Photo 14. Barbed wire fencing at roof level prevents access from adjoining rooftops.
